ENGINEERS WITHOUT BORDERS(EWB) -KNUST

**GEOTECHNICAL ENGINEERING REPORT ON CLINIC
PROJECT AT ULLO COMMUNITY, UPPER WEST REGION**

January 7, 2021

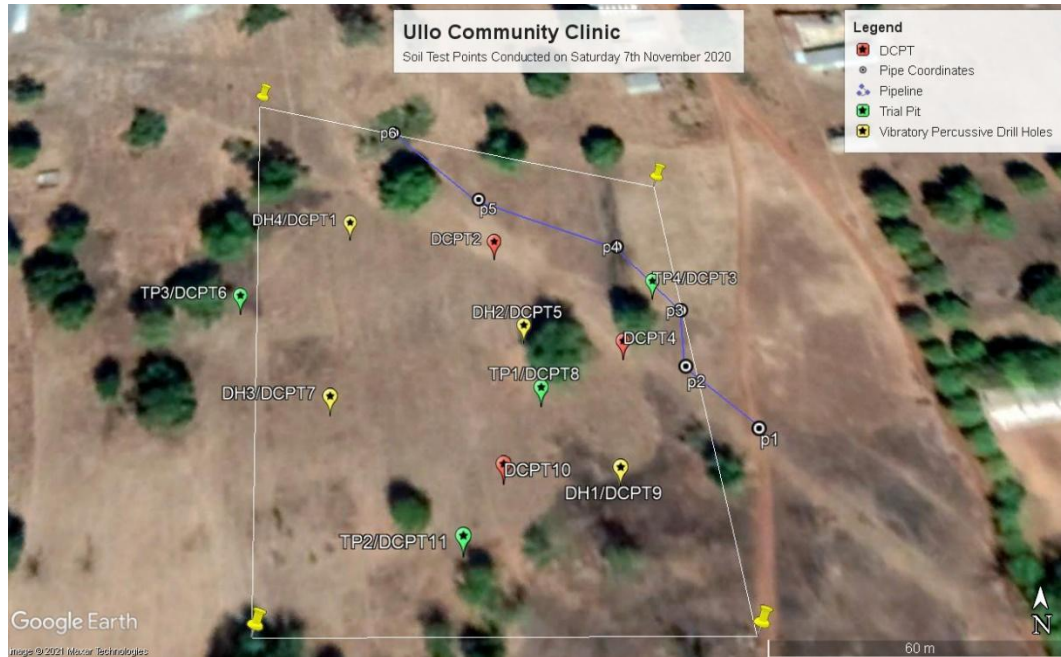
Figure 1: A google map image showing the points where all Trial pitting, DCPT and drilling took place

The proposed site is a piece of a land at Ullo in the Upper West region of Ghana. The site is about 2km from the senior high school of the Ullo community. A simplified site investigation was designed which consisted of a combination of dynamic cone penetrometer (DCP) test, manual vibratory percussive drilling and trial pitting. The fieldwork was conducted on 7th of November 2020. A total of eleven (11) points were probed with the DCP, four (4) drill holes were sunk, and four trial pits were excavated. The location of the investigation points relative to the site is shown in Figure 1.

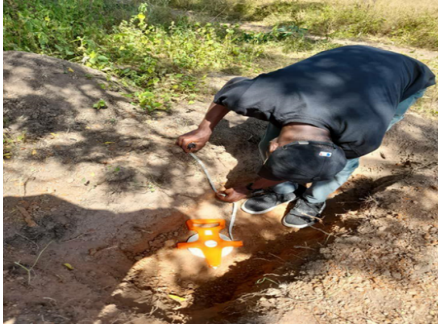
Figure 2: An image showing the trial pit being logged

Four trial pits were excavated at the site namely TP1, TP2, TP3 and TP4. The coordinates of the locations for the trial pits are given in table 1 at the appendix. The trial pits were about 0.3 m wide, 0.6m long, and depths varying between 0.3m to 0.6m. The depth of the trial pit depended on the hardness of the formation which made it difficult to excavate deeper. The trial pits were logged and samples were obtained from the different layers for Index property tests.

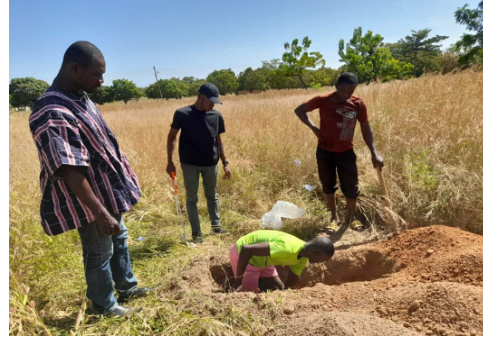
Figure 3: An image showing trial pits being dug

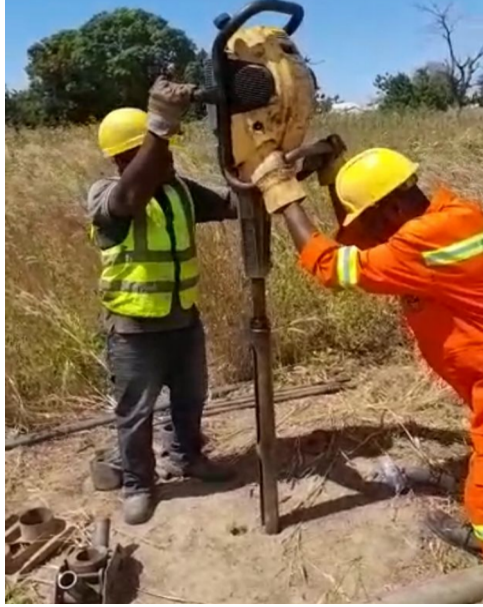
Figure 4: An image of an Auger drill in operation

Drill holes were sunk at four locations on the proposed site to obtain a field log of the subsurface profile and to obtain samples for laboratory testing. The drill holes labelled DH1, DH2, DH3 and DH4 were made using a manual percussive drilling equipment with 60mm diameter split sampler with rod attachments. The test was terminated at a depth of 0.3m for DH1, 0.7m for DH2, 3.0m for DH3 and 1.0m for DH4 on account of the hardness of the formation. Some samples were retrieved and visually logged according to the Unified Soil Classification system. Figure 4 show the manual percussive drilling in progress. The samples were collected in plastic bags, labelled, and sealed for further analysis at the KNUST Soils laboratory. The results of the DCP blows-penetration plot are superimposed on the field logs of the drill holes in the appendix.

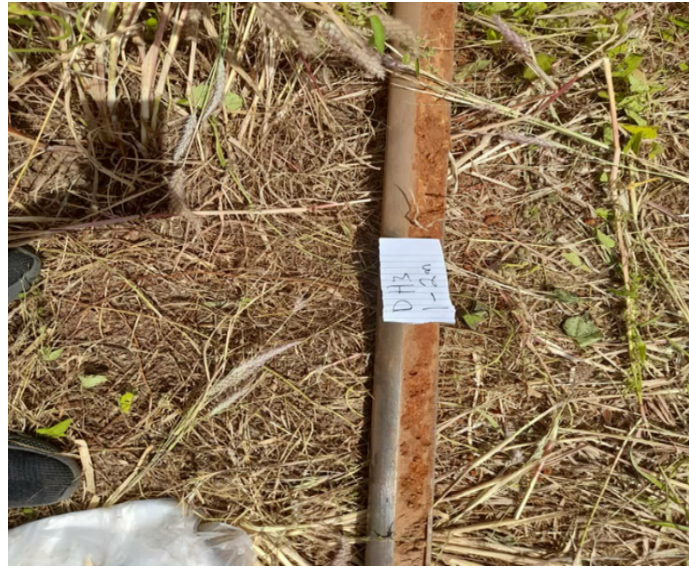
Figure 5: An image of a sample obtained by Auger drilling

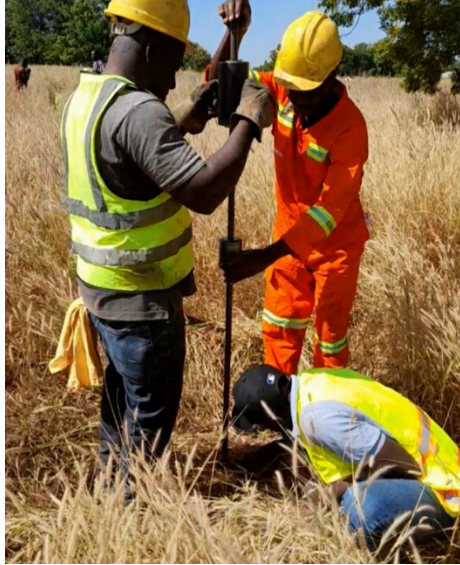
Figure 6: An image showing DCPT test in progress

The Dynamic Cone Penetrometer (DCP) Test was conducted at eleven (11) locations. The test was conducted at the drilling points, trial pitting points and three (3) additional points. The DCP equipment used in this investigation consisted of a 10kg hammer dropping over a height of 460mm to strike an anvil that drove a 60° cone into the ground. During the DCP test, at each DCP point the hammer was allowed to fall freely and the number of blows required to drive the cone 100mm into the ground (designated DCP n-value, N_{DCP}) was recorded against the penetration. The details of the results of the number of blows against the penetration for the eleven (11) DCP points are given in the Appendix. Figure 6 shows the DCP test in progress.

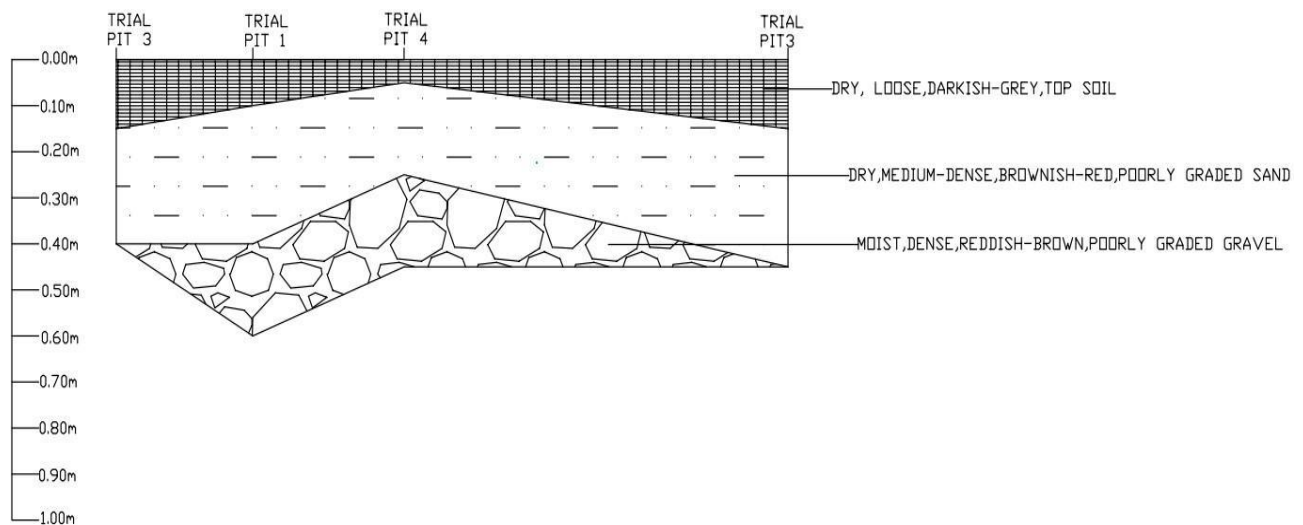
Figure 7: Cross-section Profile describing the proposed site with reference to only Trial pits.

The soil profile encountered at the site with respect to the trial pits shows a very dry, medium-dense topsoil of about 0.1m thick. Beneath this topsoil there exist a layer of dry, medium- dense, brownish-red, poorly graded sand with average thickness of about 0.3m. The final layer encountered beneath the aforementioned layer has an average thickness of about 0.2m and can be described as a, moist, dense,

reddish-brown, poorly graded gravel. Digging deeper than a depth of about 0.8m either by means of trial pitting or auger drilling is difficult suggesting the presence of a stiff material perhaps a soft rock relatively very close to the surface of the ground. However, there was an exception for on the drill holes precisely DH3 which went deep to about 3m. The earth material sampled from that hole was inadequate to perform the classification test but by inspection from about 1.0m mark to about the 3m mark one can suggest it to be dense, damp, reddish –brown, clayey sand.

Groundwater was not encounter in any of the trial pits or the drill holes. Below is cross-section profile of classification and description information from only the trial pits.

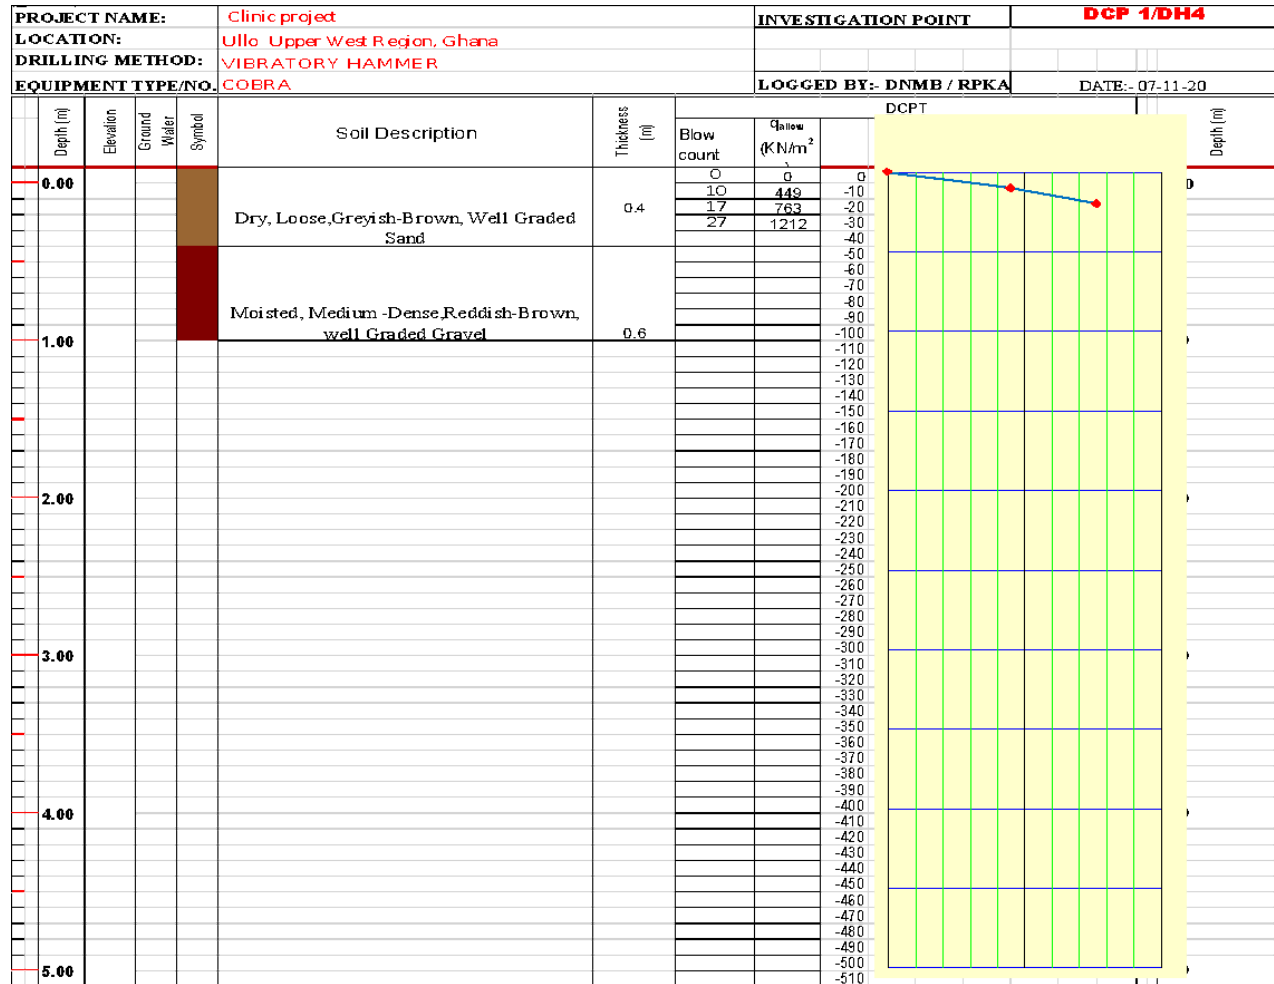
Figure 8:Drill hole Logs for DCP1/DH4

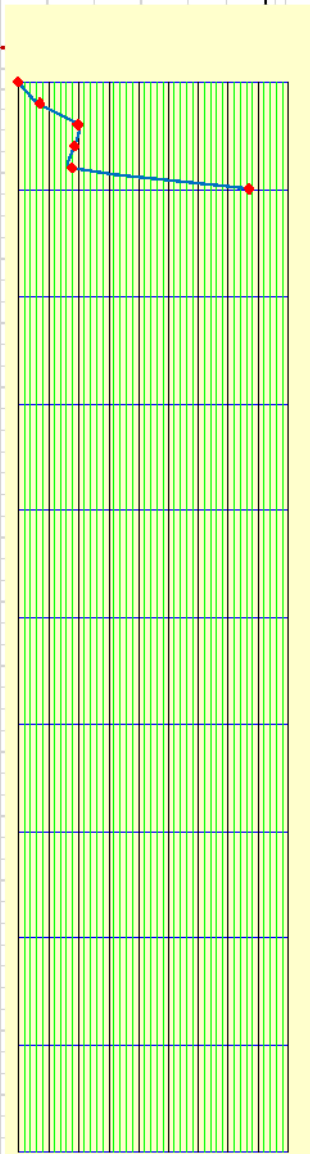
PROJECT NAME:		Clinic project				INVESTIGATION POINT		DCP 3(TP4)	
LOCATION:		Uilo Upper West Region, Ghana							
DRILLING METHOD:		VIBRATORY HAMMER							
EQUIPMENT TYPE/NO.		COBRA				LOGGED BY:- DNMB / RPKA		DATE:- 07-11-20	
Depth (m)	Elevation	Ground Water	Symbol	Soil Description	Thickness	DCPT			Depth (m)
						Blow count	q ₁₀₀ (KN/m ²)

0.00				Dry, loose ,Darkish-Grey, Grading, (Topsoil with plant roots)	0.05	0	0	-10	0
				Grey ,Dry, Medium-dense, Poorly Graded Sand	0.2	8	359	-20	
						22	988	-30	
						21	943	-40	
				Dry, dense, Reddish-Brownish, grading,	0.2	20	898	-50	
						86	3861	-60	
								-70	
								-80	
								-90	
								-100	
								-110	
								-120	
								-130	
								-140	
								-150	
								-160	
								-170	
								-180	
								-190	
								-200	
								-210	
								-220	
								-230	
								-240	
								-250	
								-260	
								-270	
								-280	
								-290	
								-300	
								-310	
								-320	
								-330	
								-340	
								-350	
								-360	
								-370	
								-380	
								-390	
								-400	
								-410	
								-420	
								-430	
								-440	
								-450	
								-460	
								-470	
								-480	
								-490	
								-500	
								-510

Figure 10: Trial pit Logs for DCP3(TP4)

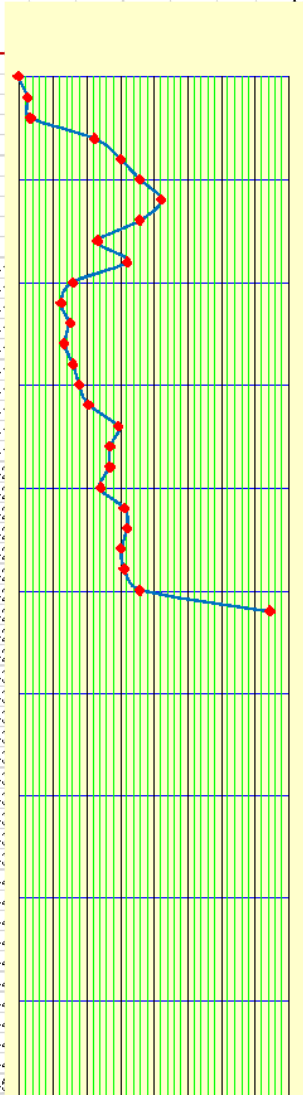
PROJECT NAME:					Clinicproject					INVESTIGATION POINT					DCP 4(btn TP4&TP1)															
LOCATION:					Uilo Upper West Region, Ghana																									
DRILLING METHOD:					VIBRATORY HAMMER																									
EQUIPMENT TYPE/NO.					COBRA					LOGGED BY:- DNMB / RPKA					DATE:- 07-11-20															
										DCPT																				
Depth (m)		Elevation		Ground Water		Symbol		Soil Description					Thickness		Blow count		q _{slow} (KN/m ²)

0.00															0		0		0.00											
															3		135													
															4		180													
															25		1123													
															34		1527													
															40		1796													
															47		2110													
															40		1796													
															26		1167													
															36		1616

1.00															18		808		1.00											
															14		629													
															17		763													
															15		674													
															18		808													
															20		898													
															23		1033													
															33		1482													
															30		1347													
															30		1347

2.00															27		1212		2.00											
															35		1572													
															36		1616													
															34		1527													
															35		1572													
															40		1796													
															83		3727

Figure 11:Drill Hole Logs for DCP4(between TP4&TP1)

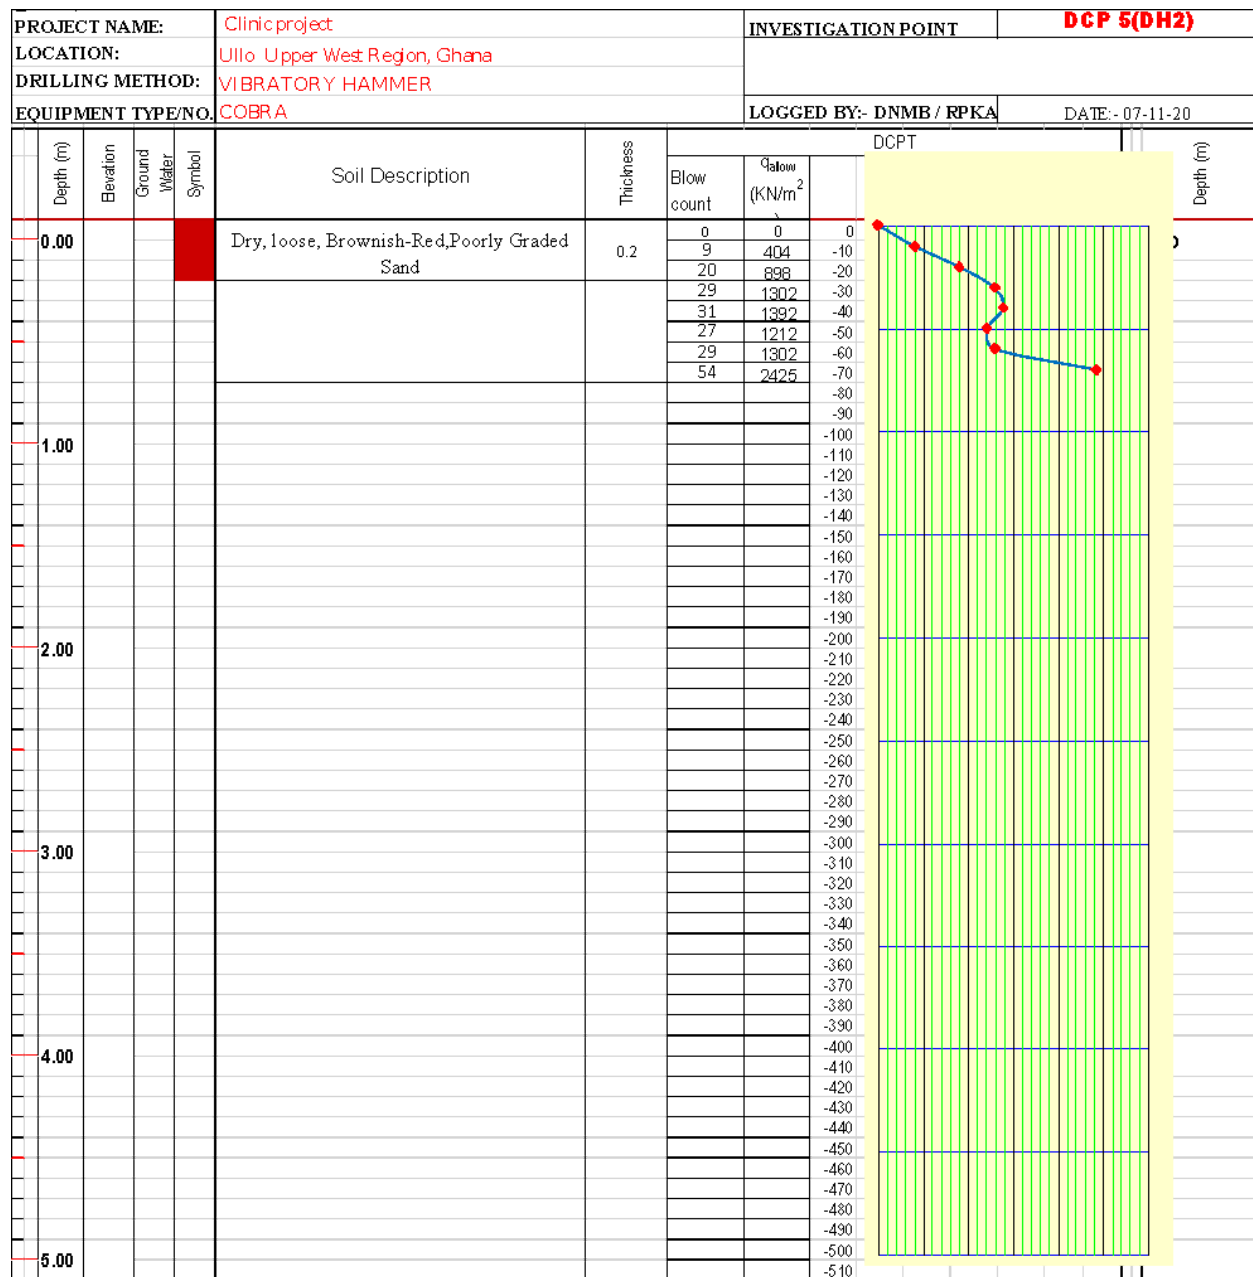
Figure 12: Drill Hole Logs for DCP5(DH2)
